HO-123

Clark Family Farm  
15081 Roxbury Road  
Roxbury Mills vicinity

## Maryland Inventory of Historic Properties Form

historic Clark Family Farm  
other George Chase Brick House

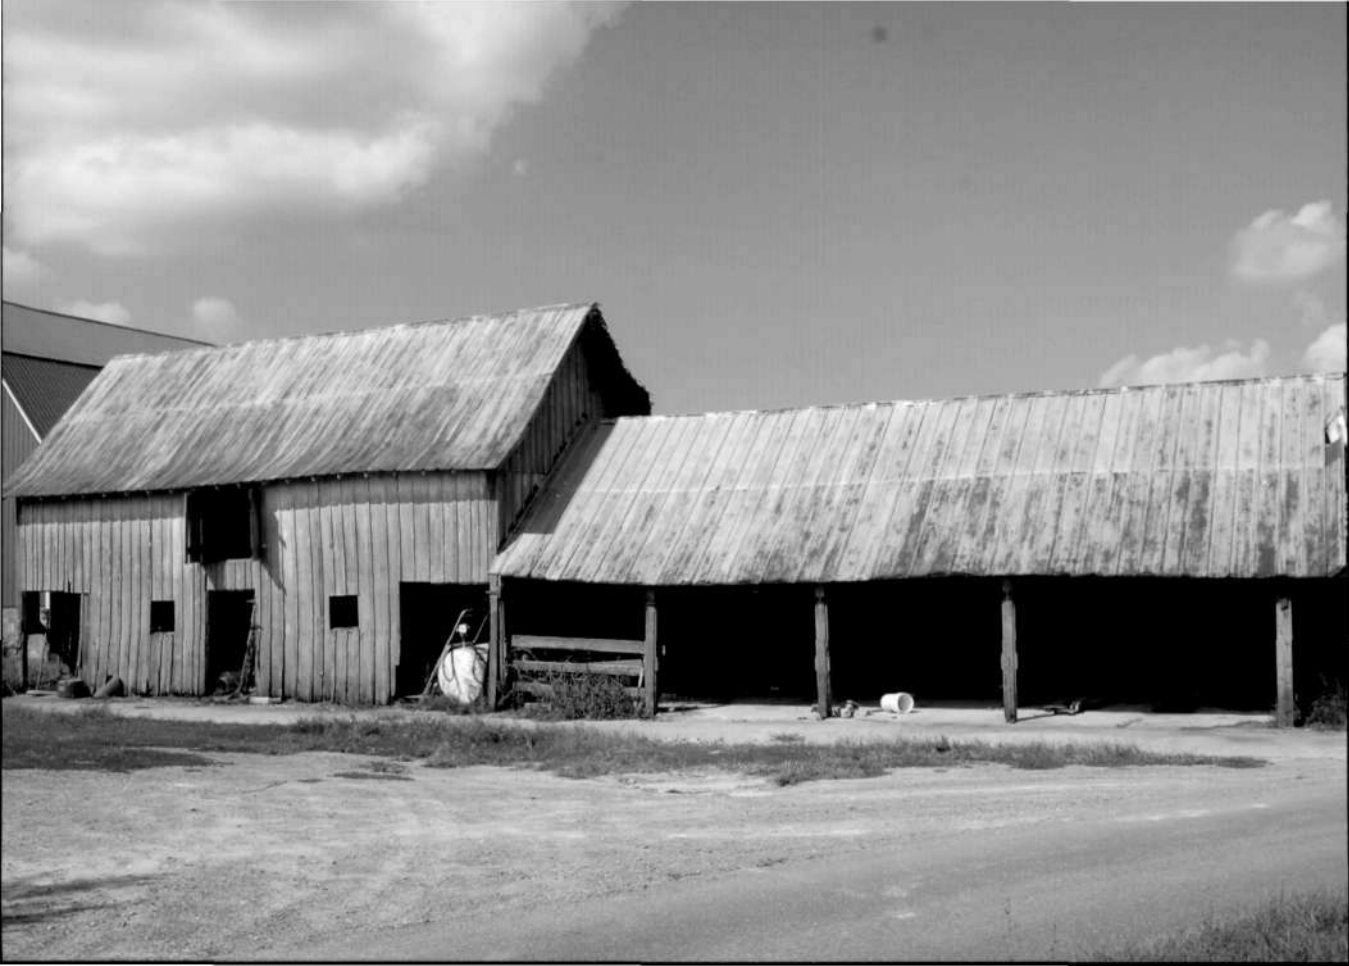
14/16

Stable, south elevation

There is a frame stable located about 150 feet southwest of the house. It is a two-story, five-bay by one-bay frame structure with board-and-batten siding fastened with wire nails, a CMU foundation, and a gable roof of inverted V-seam metal, an east-west ridge, and a kick at the eaves. The eaves are open, with exposed circular-sawn 2 by 4 rafters. On the south elevation, the first story has door openings in the west, east, and center bays and window openings in the west-center and east-center bays. The second story has a pair of vertical-board doors in the center. The east and west elevations have no openings, while the north elevation has window openings in the east and west bays of the first story and the second story is covered in vines. The east end has an open shed attached to it that has a board wall on the north side and four posts on the south side. The shed has a gable roof with a ridge that runs east-west. The first story of the stable has aisles that run north-south in the east and west ends, and in the center, with two stalls between each pair of aisles. The stalls are set back to back, one to the north and one to the south, and are accessed from the end aisles, not the center aisle. The building is constructed with a circular-sawn heavy timber frame and is wire-nailed. There are posts and sills that are 6-1/2 inches by 7-1/2 inches with four-inch-square braces and horizontals. The north and south wall posts are trenched for ledger boards that support the joists. There is also a summer beam in the center to support the joists, and it is constructed of four ganged-together 2-inch by 9 1/2-inch planks. The joists are 2 inches by 7-1/2 inches and are lapped in the center. The north window sash were constructed to slide open and closed. There is a ladder in the center of the north wall leading to the upper story. The west wall has a board on it that contains large pegs. The second story is completely open, with no openings on the north wall. The rafters are 2 by 6s that are mitered and butted at the ridge, with short collars nailed to them at the peak. The rafters sit on 2 by 6 plates on top of the posts, with short kick rafters nailed to the sides.

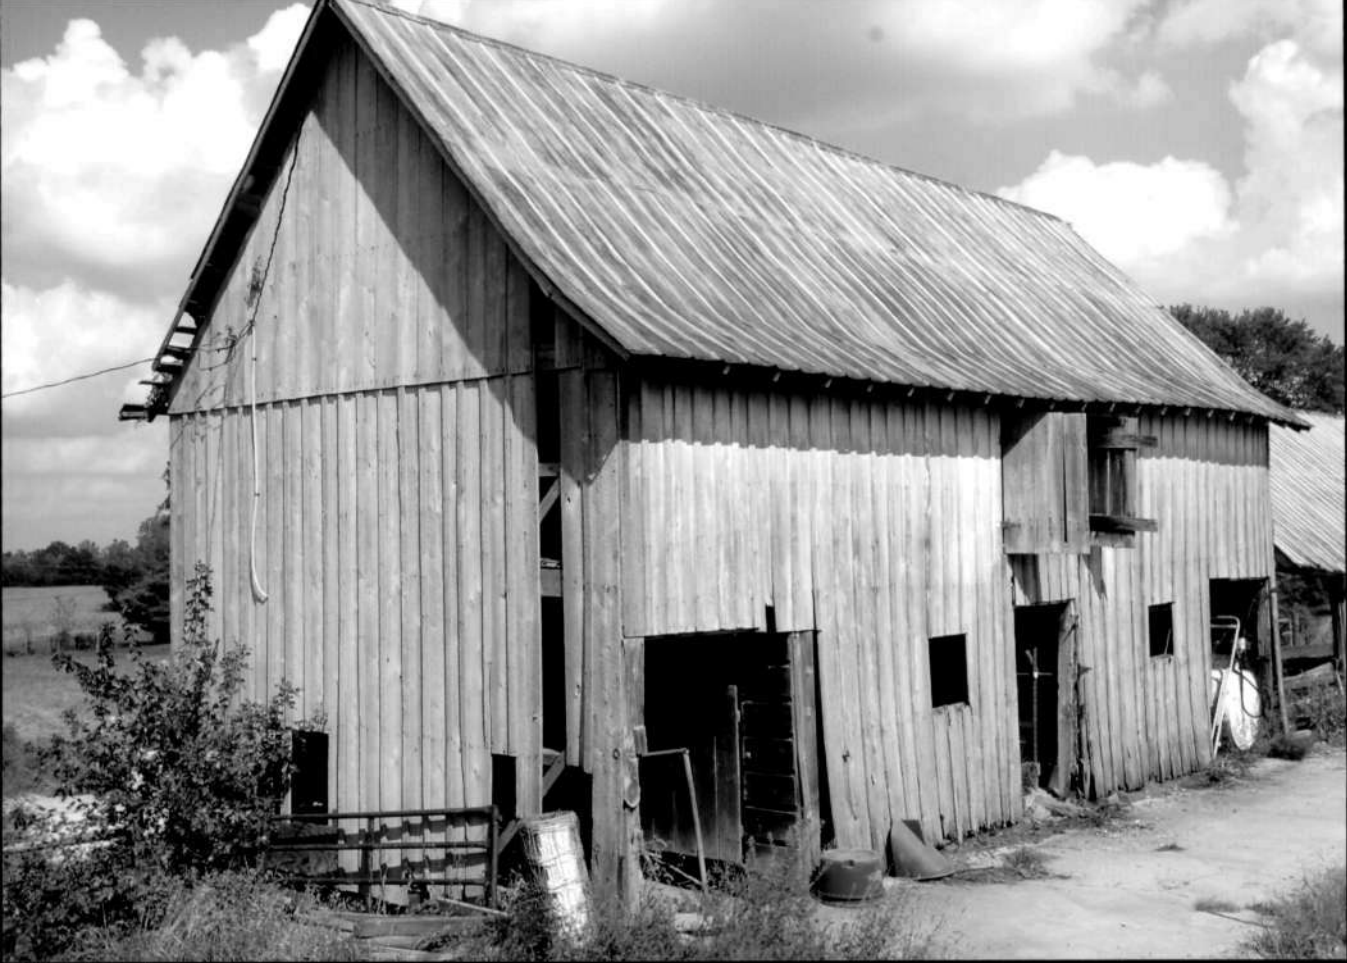
15/16

Stable, west and south elevations

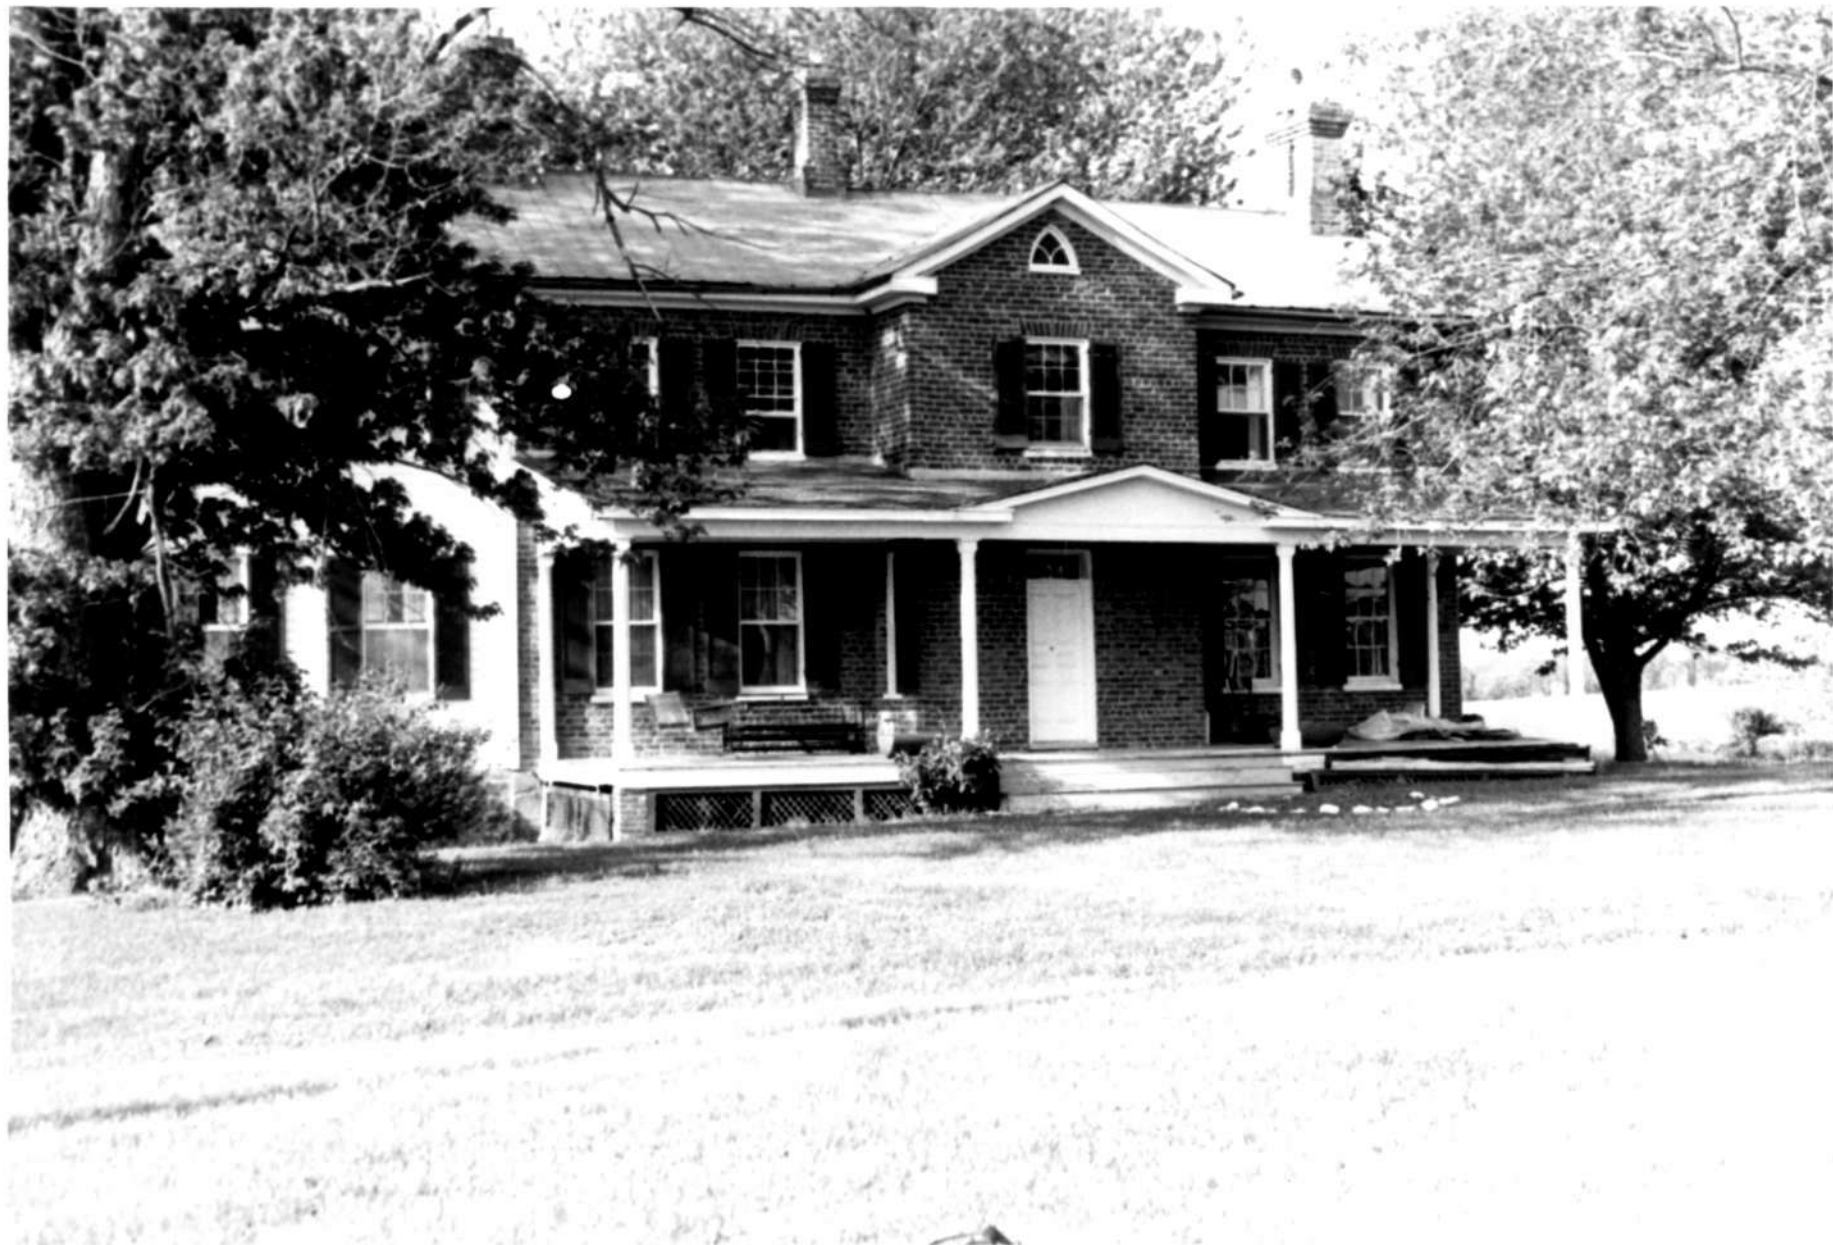
Ho-123  
George Chase Brick House  
South -  
May, 1979  
CB Thompson, ALCP

It is a five bay wide, one room deep, two story high, gabled roof (running east-west) brick (laid in English garden wall brick bond) house, resting on a stone foundation, with wide brick, corbeled edged chimneys, inset into its east and west walls and another square brick chimney west of center. A two-bay wide, one room deep, two story high, gabled roof (running east-west) German siding, frame kitchen wing, resting on a stone foundation, rests along the building's west wall. Extending north from the center of the north wall of the brick-frame building is a one story high, one room deep, one room wide, gabled roof (running north-south) old stone kitchen wing, with square brick chimney inset into its north wall. The brick section's north wall features an open bible, cross paneled, four light entrance door surmounted by a three light transom and stretcher brick, flat arched lintel, in the second west bay. A central, three light basement window rests in the stone foundation of this wall. The south elevation features an open bible and cross paneled entrance door in its projecting central bay, which is surmounted by a three light transom and decorated with a stretcher brick, flat arched lintel. A single, double-hung, four-over-four light, rectangular window, decorated with a stretcher brick, flat arched lintel, and underlined by a projecting wooden sill, rests in the east and west walls of this projecting bay. A second floor, rectangular, double-hung window, holding six-over-six lights, surmounted by a stretcher brick, flat arched lintel, underlined by a projecting flat sill and decorated by wooden shutters, rests above central entrance and is surmounted by a Gothic arched, three light attic window above.
